HISTORIC STRUCTURE REPORT
on the
MOUNT ZION OLD SCHOOL BAPTIST CHURCH
Loudoun County, Virginia

Chapters I-VI
(90% Complete)

Prepared for
Loudoun County Virginia
Parks and Recreation Department

Monday 23 February 1998

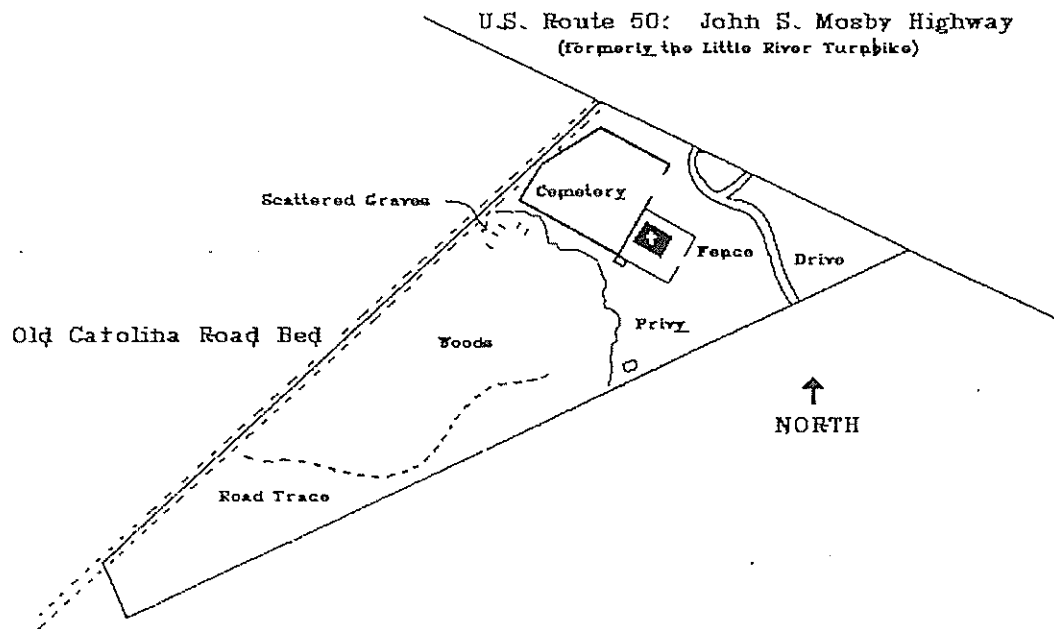
Figure 3: Site Plan: The church site was a portion of the Ritcor family land which had been separated from the family's main holdings by the construction of the Little River Turnpike (now U.S. Route 50). Today the bed of the Old Carolina Road is part of the property. (Plan from Grier Study, 1992)

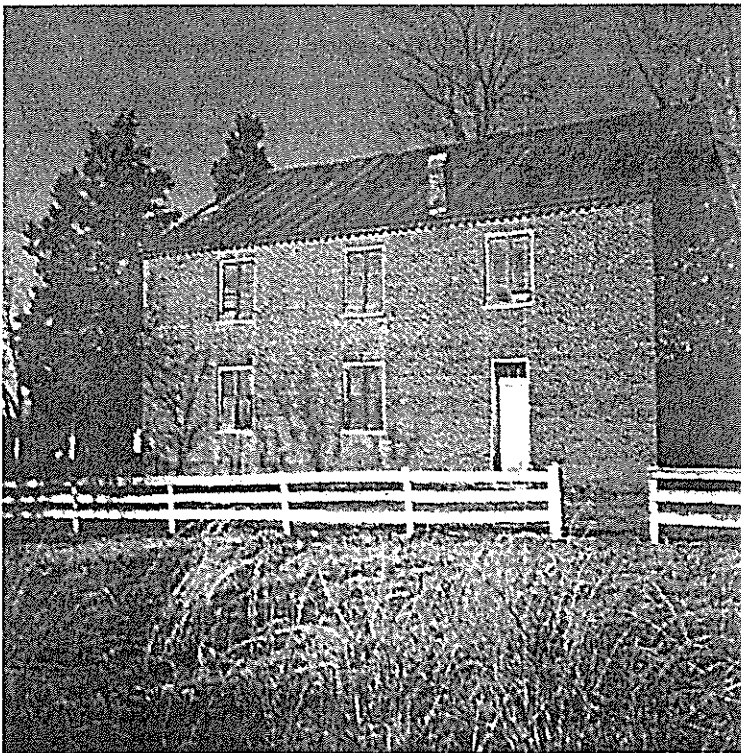
Figure 4c: South Elevation. Although this image was taken recently, it shows the east elevation's configuration as originally built (Roofing shown in the photographs is not original). Both north and south elevations are three-bay compositions with entries to balcony stairs occupying the easternmost bays. The vertical beaded board door shown is not original, and was likely replaced due to damage from the Civil War period. The corbelled cornice was built to resemble that found at the Pleasant Vale Baptist Church in Fauquier County. (Image taken: 11/97)

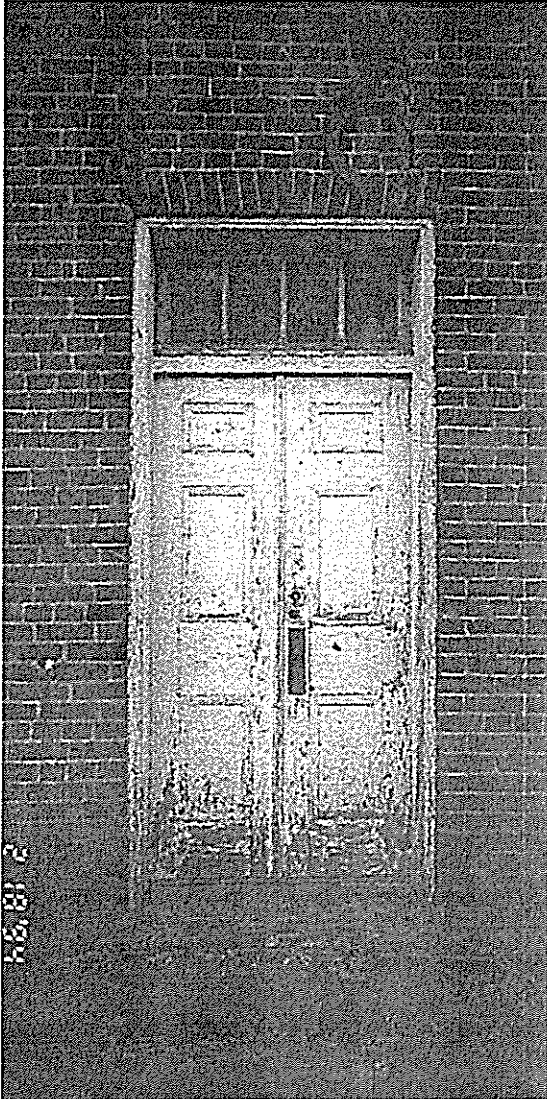
Figure 6: East Doorway. The recessed panels are 12" wide and 6-1/8," 21-5/8," and 19-1/4," tall respectively. Panel edge trim consists of a simple 1-1/2" profile. Center stiles are 3-1/2" and outer stiles are 4-1/2." The doors' rails measure 9" tall at the foot, to 11-3/8" at knob height, and 4-5/8" at the two upper rails. (Image taken: 11/97)

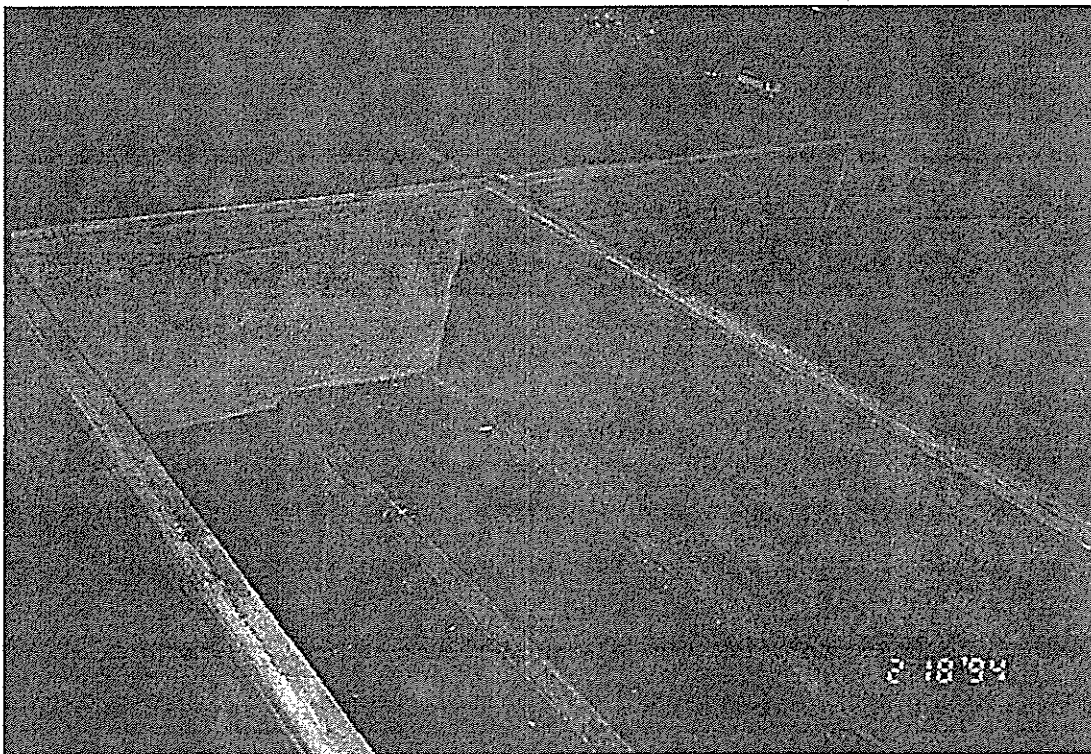
Figure 8: The central section of pews in the Church Hall is bisected by vertical board, dividing the men and women who attended services and meetings. Women occupied areas north of the divider and men occupied those to the south. (Image taken: 11/97)

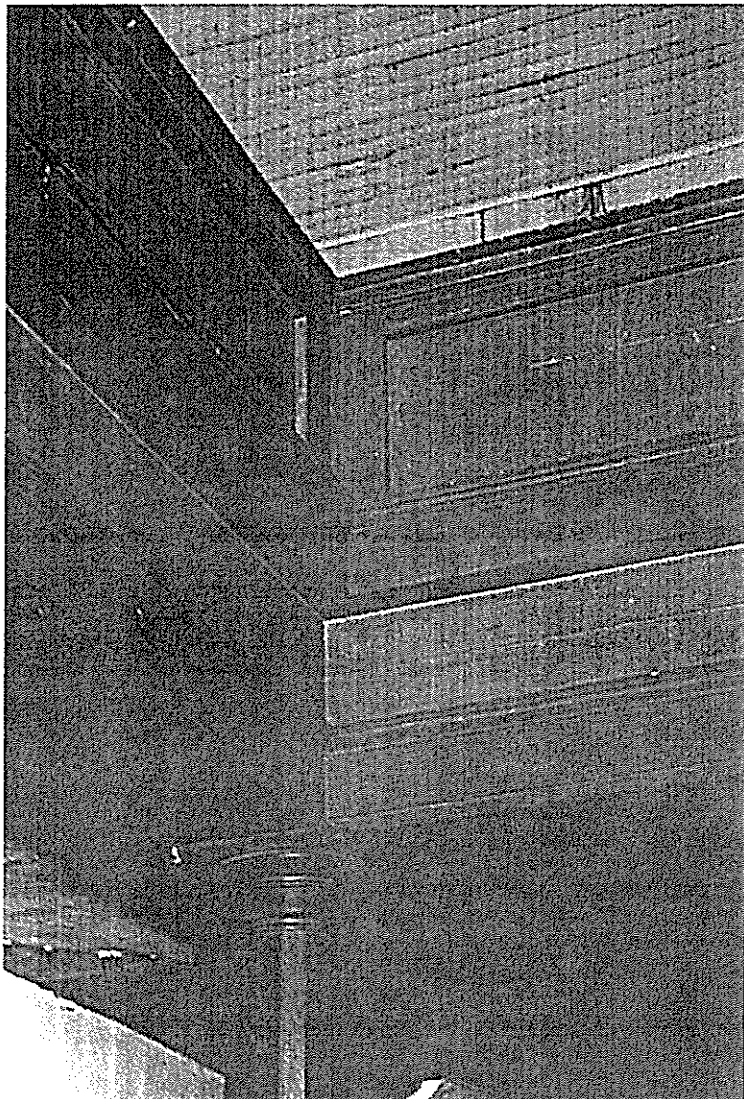
Figure 19: Column Capital and Balcony Rail. Each column's sixteen-sided column casing is comprised the eight three-sided segments. The guardrail above is cased with dark walnut-stained trim around blond burlled panels. (Image taken: 11/97)

The front of the 2'-4" high balcony guard rail is cased with dark walnut-stained trim around blond wood recessed panels. The walnut-stained edge trim has a clear finish, while panels have been burlled with a reddish stain. The guardrail's top edge is cased with a 1-1/4" flat cap, and a simple decorative trim profile surrounds the recessed panels. Below this panel, a 4" ledge is cased similarly, with a 1" flat nose above 3" decorative trim. A recessed band of wood below the guardrail is blond wood with a uniform yellow stain. Edge trim around this panel is simply profiled dark walnut-stained, matching the rail edge trim. The balcony guardrail trim appears to be in very good condition.

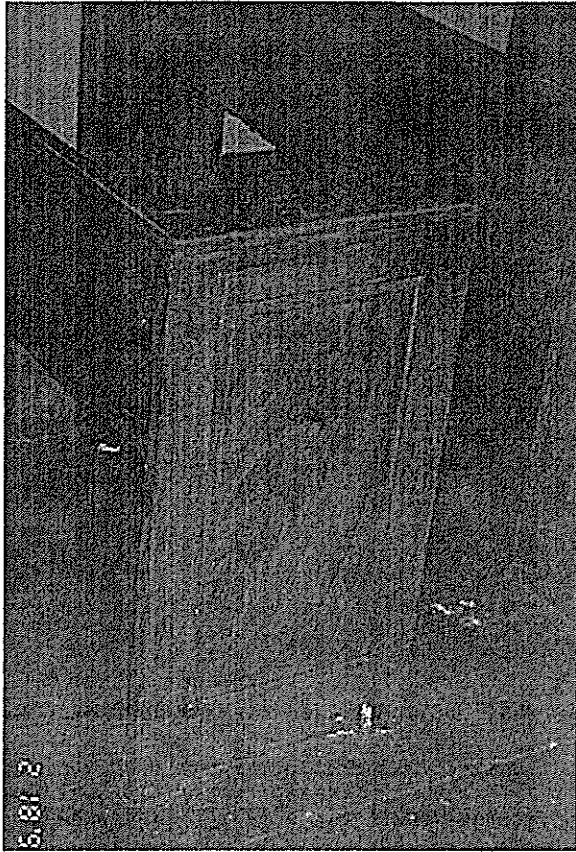
Figure 20b: Pews. The pews are likely of the post-civil war era as the congregation petitioned for the cost of their replacement in 1905. The paint is a reddish burling on the blond wood. (Image taken: 11/97)

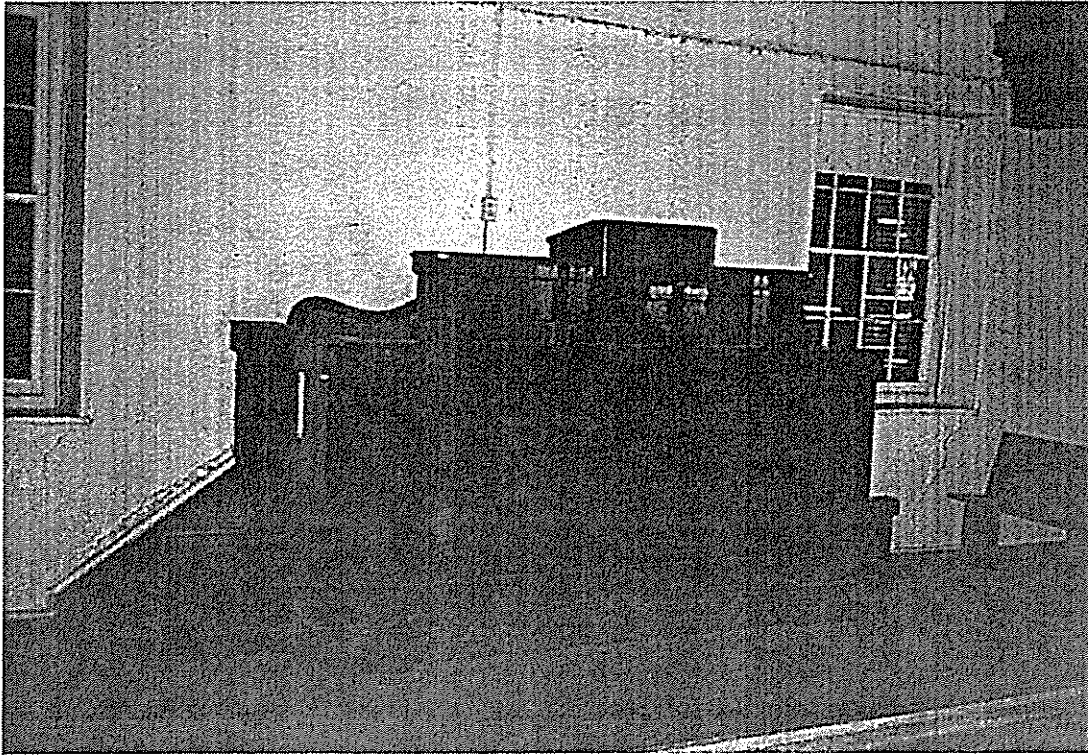
At the center of the west end of the main hall, a 7-3/4" high carpet covered platform supports the church's pulpit (*Figure 21*). A 3/4" quarter round has been added to the base at west, in order to conceal gaps caused by the deformation of the west wall. The floor of the speaker's area behind the pulpit is raised approximately another 22" above the platform, although this podium area floor deflects considerably downward toward the west. It can be reached from the north or south side of the platform, via three steps. A wood screen with a 3-1/2" base conceals these steps from the congregation on both north and south sides. The pulpit itself steps upward from the step screens at heights of 3' 8" and 4' 8" above the platform, and has a 6-3/4" base. The difference between base heights as well as a complex joint between the step structure and the pulpit structure indicates that they may be of different eras.

Figure 21: Pulpit. The pulpit stands on a 7-3/4" high 8'-0"x12'-0" carpet covered platform at the center of the west wall. The pulpit base is 6-3/4" while the base of the wood screens in front of the adjacent steps is 3-1/2." (Image taken: 11/97)
